Case Study

LOCATION OF JOB: Peak Downs Mine, QLD
CLIENT: BHP Billiton
CONTRACT VALUE: \$2.5M

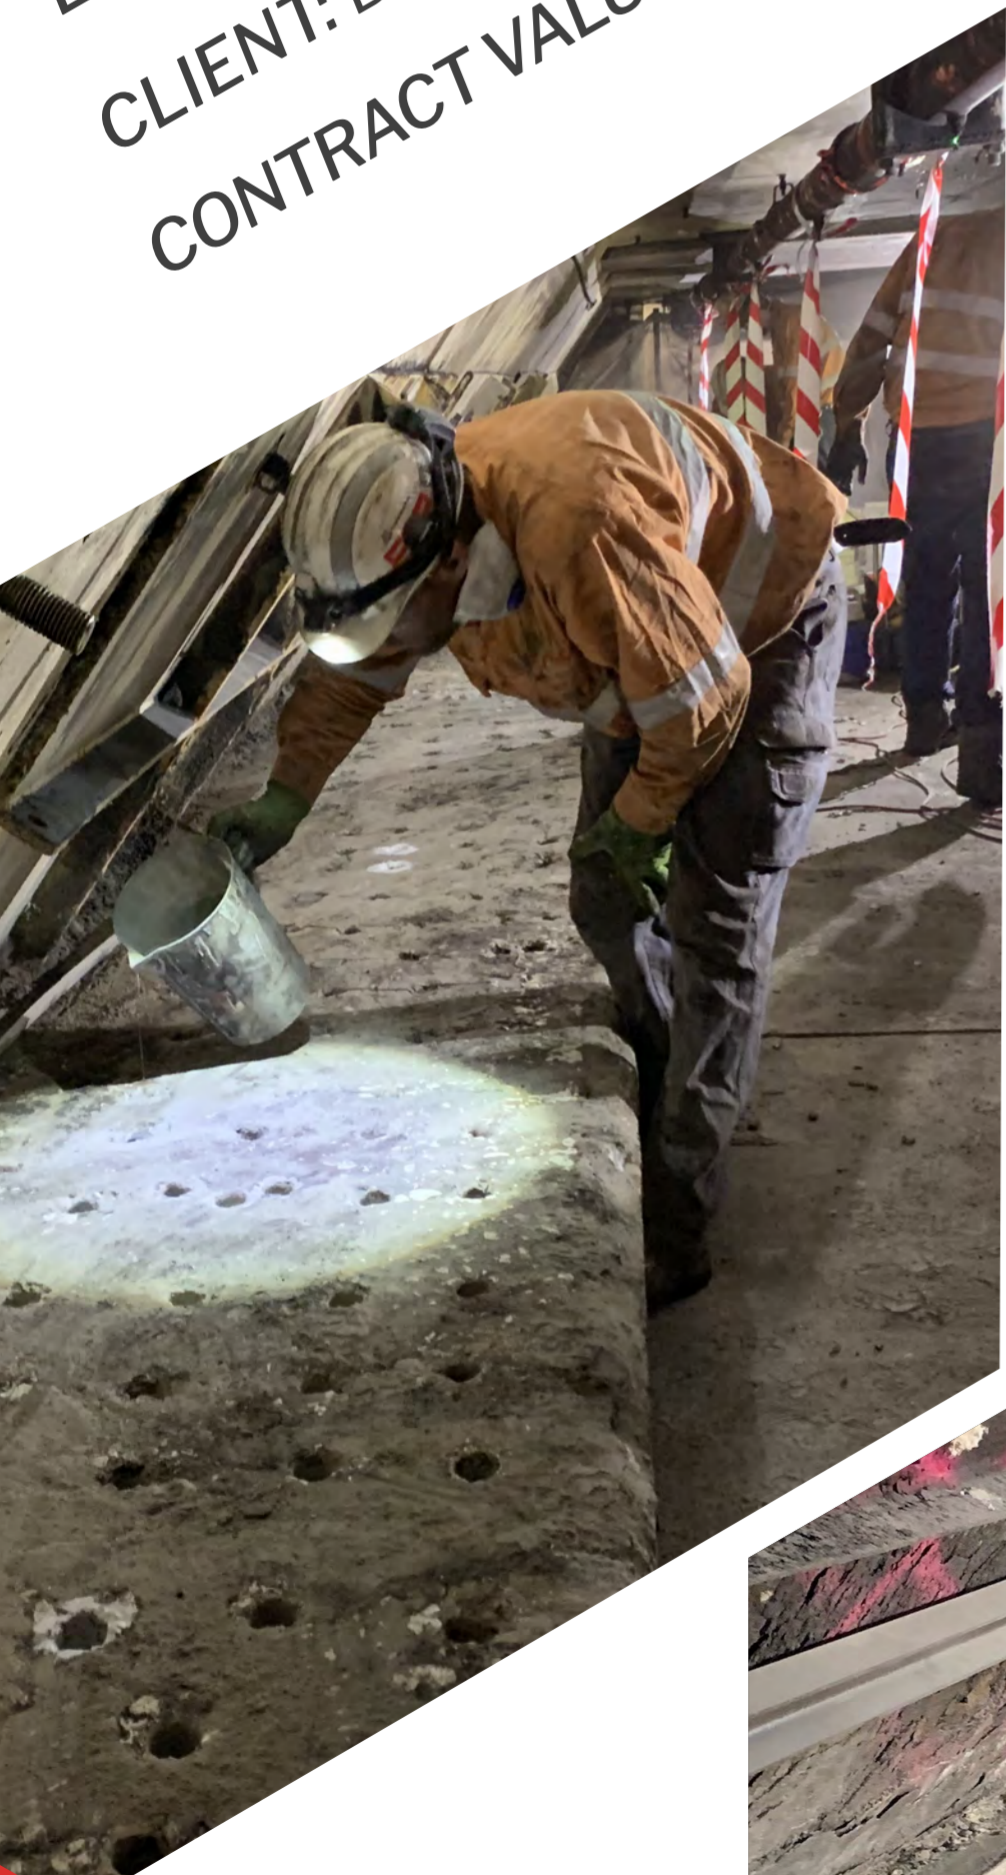
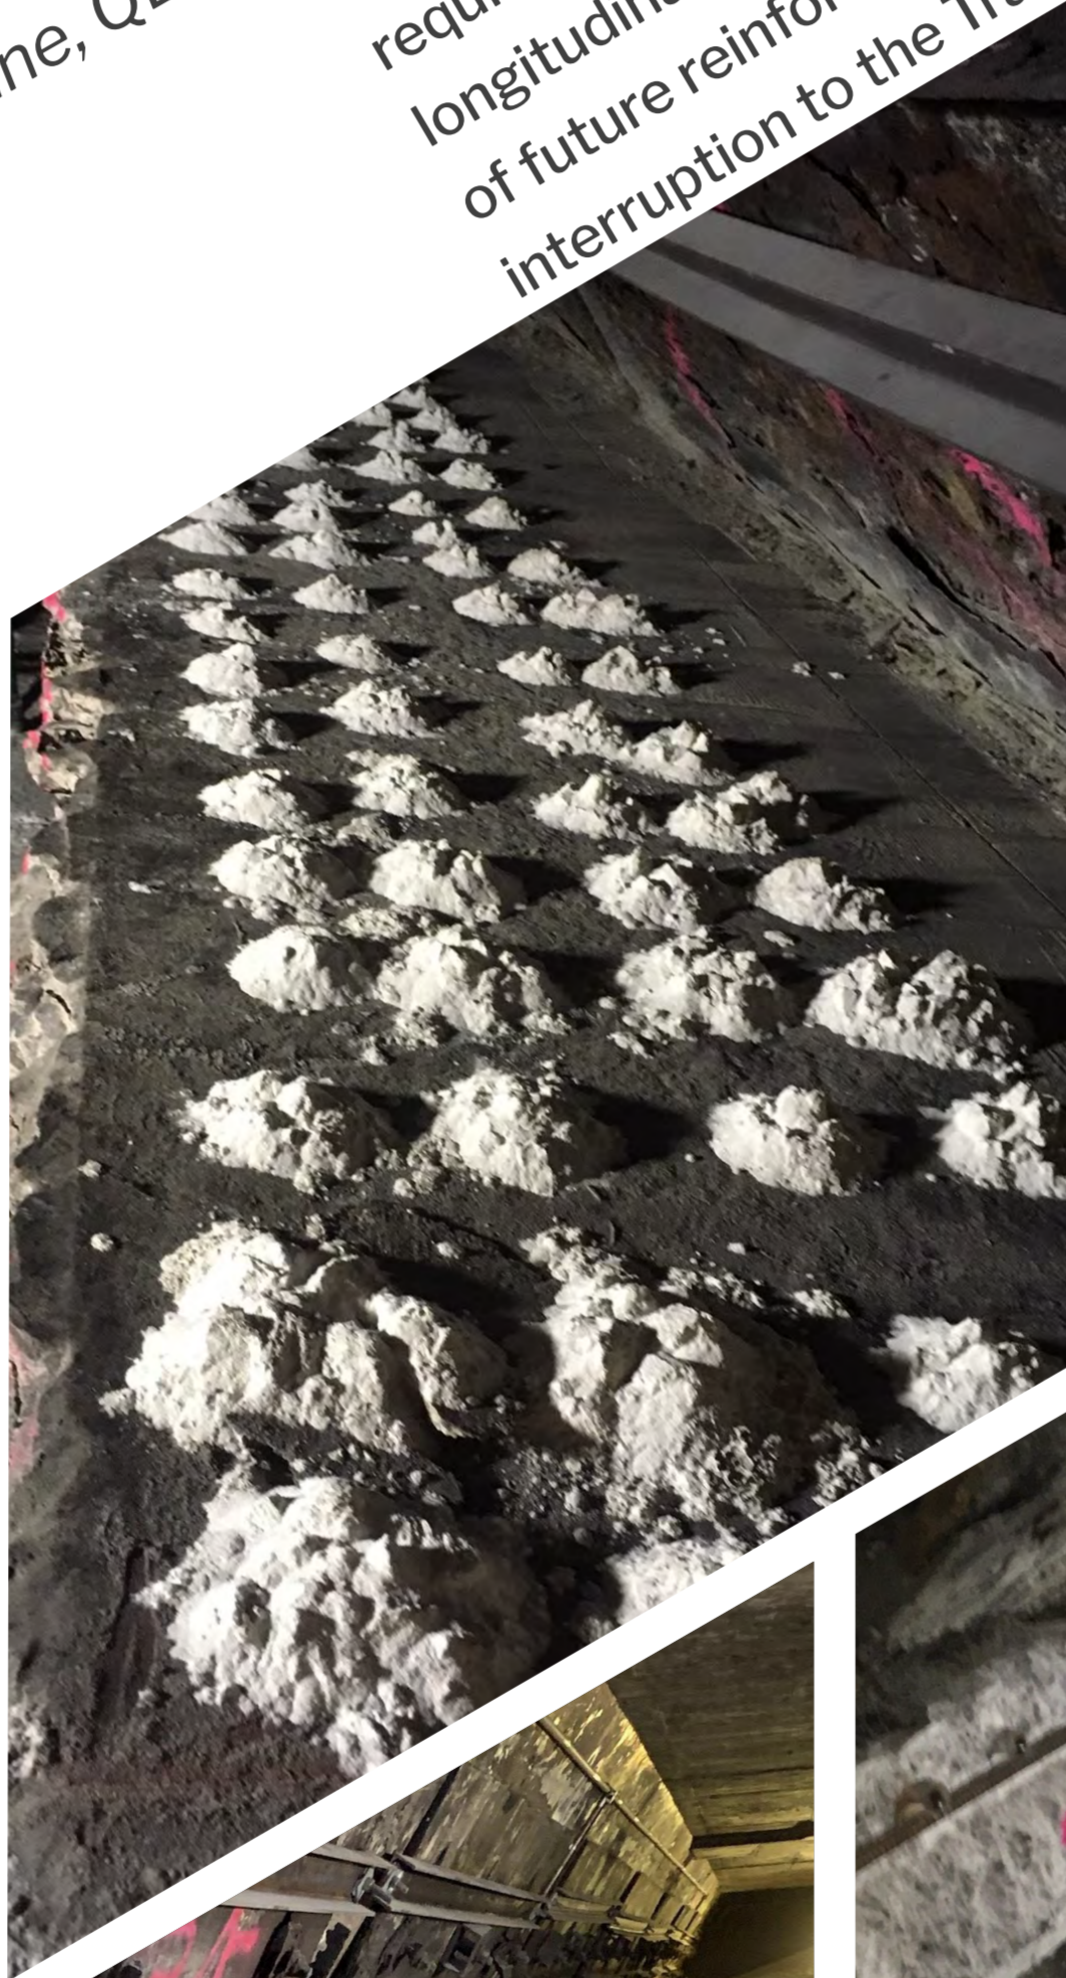
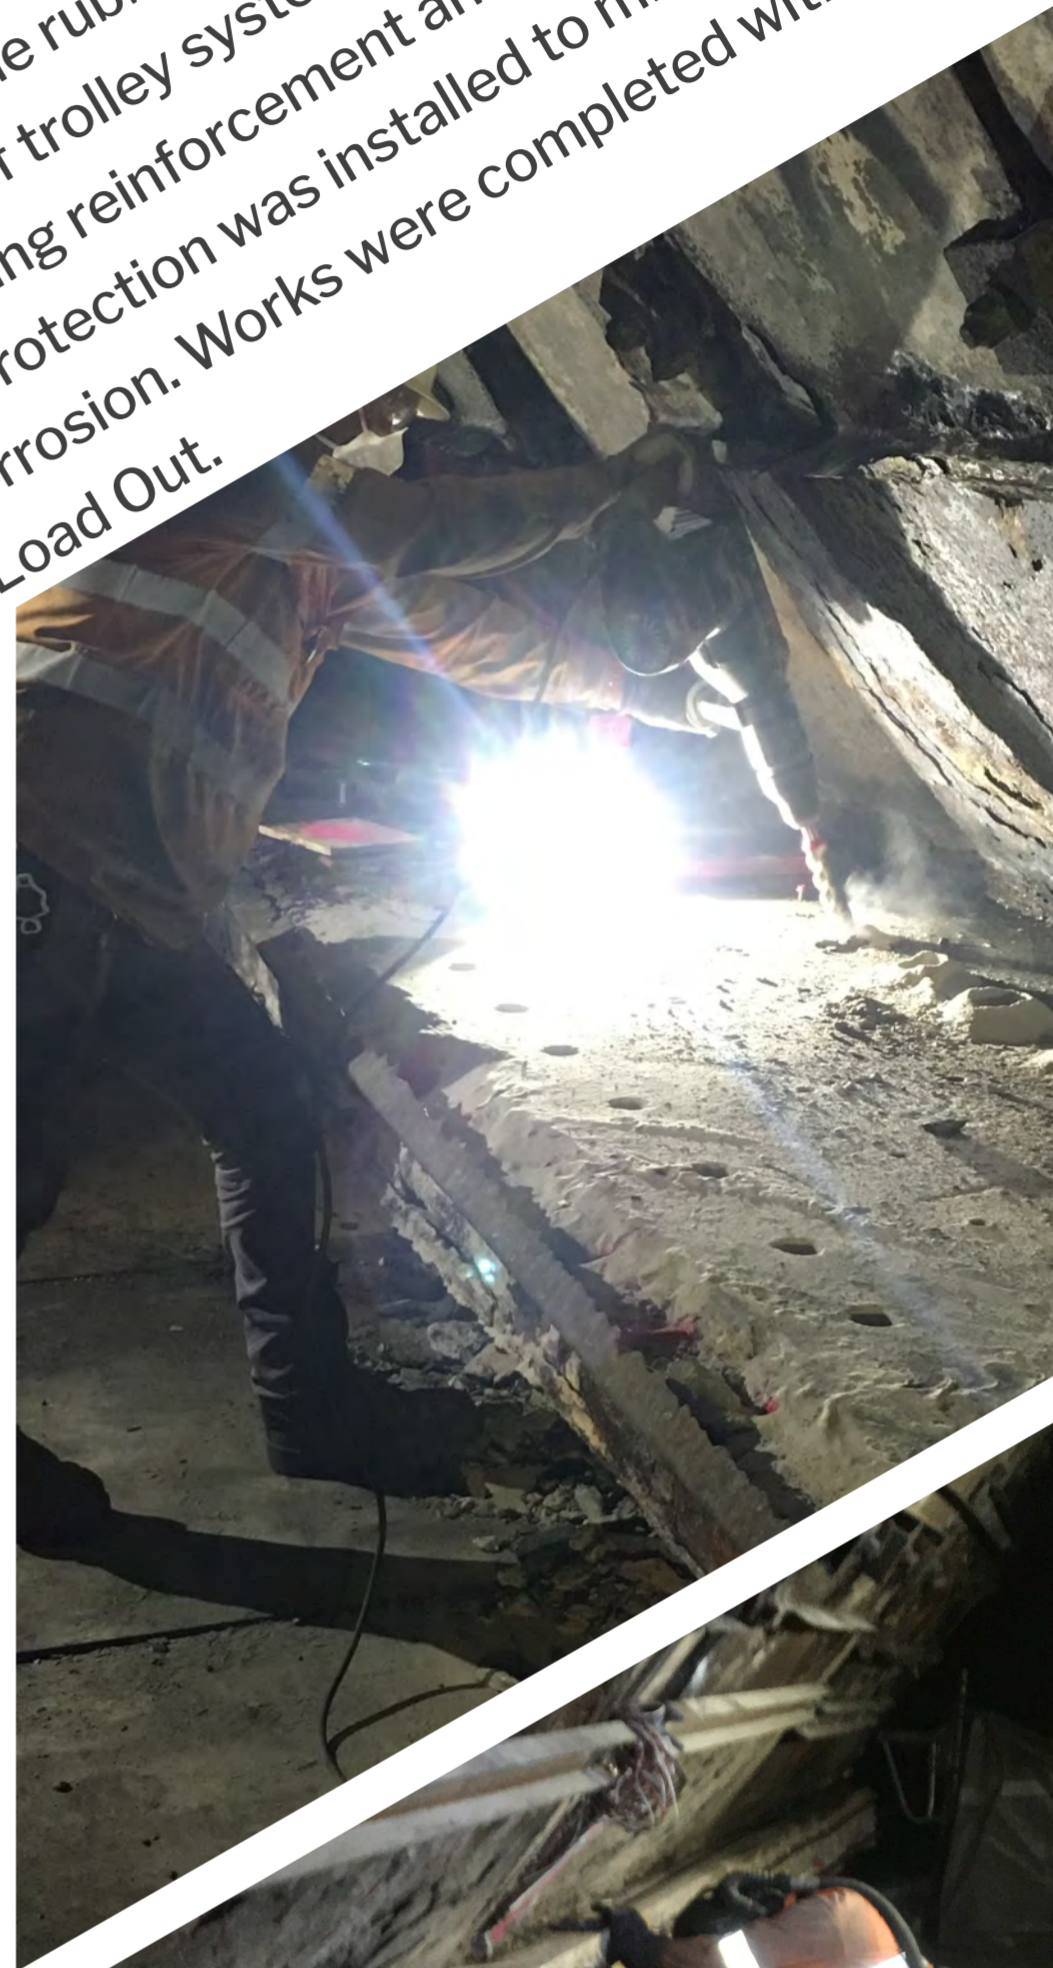
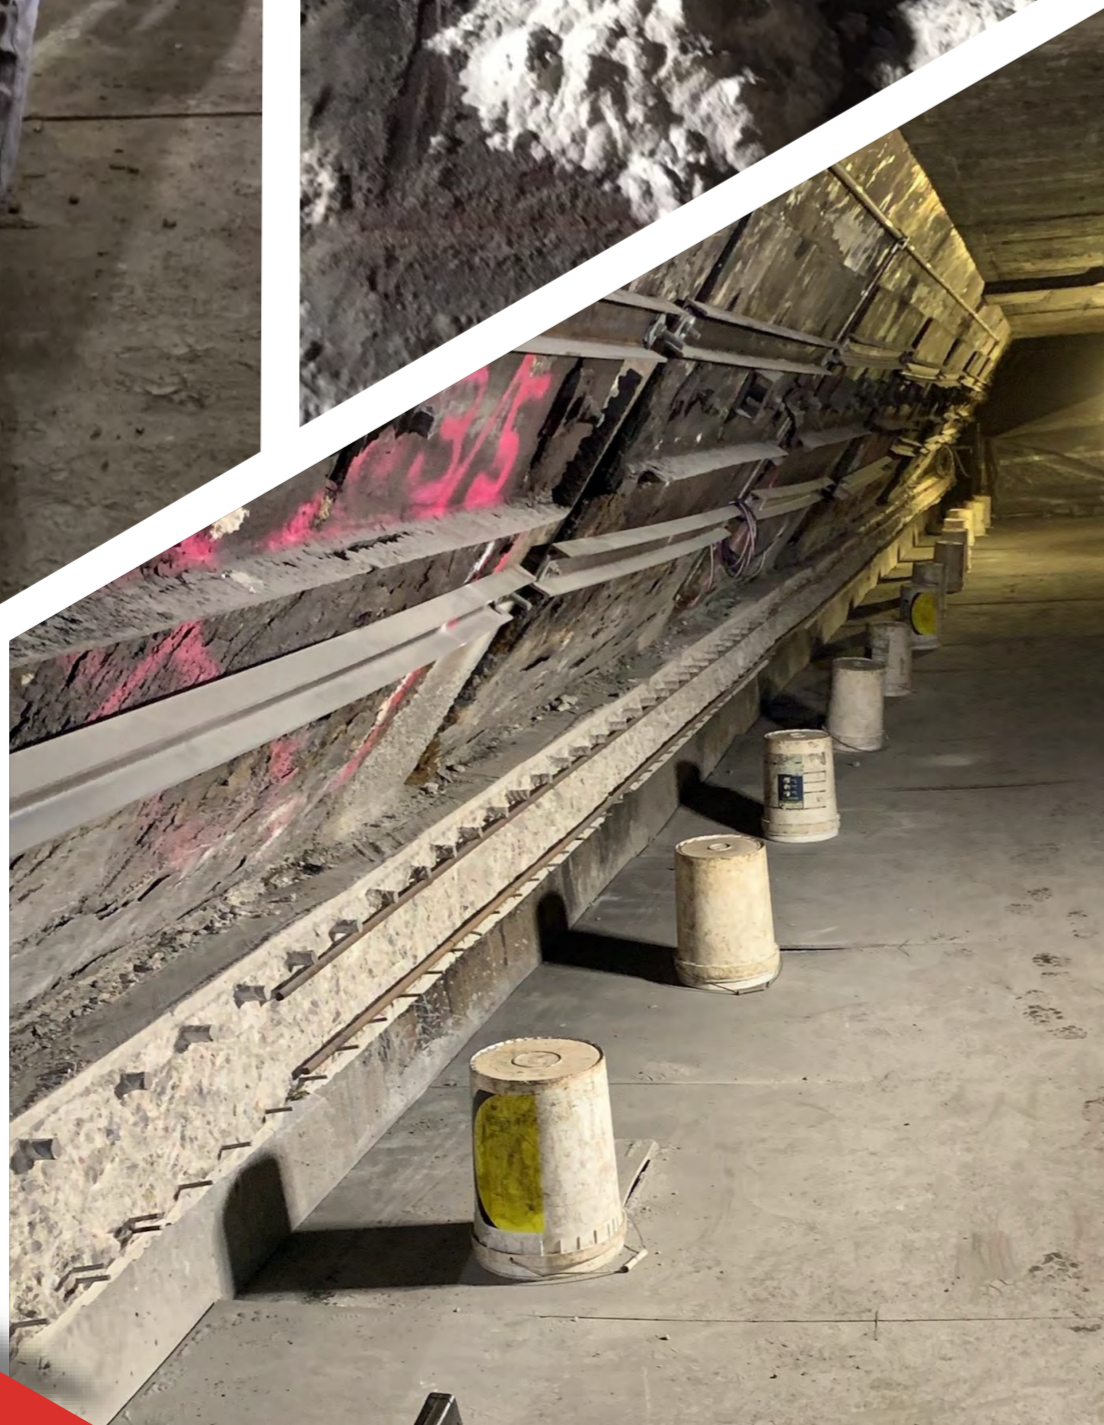
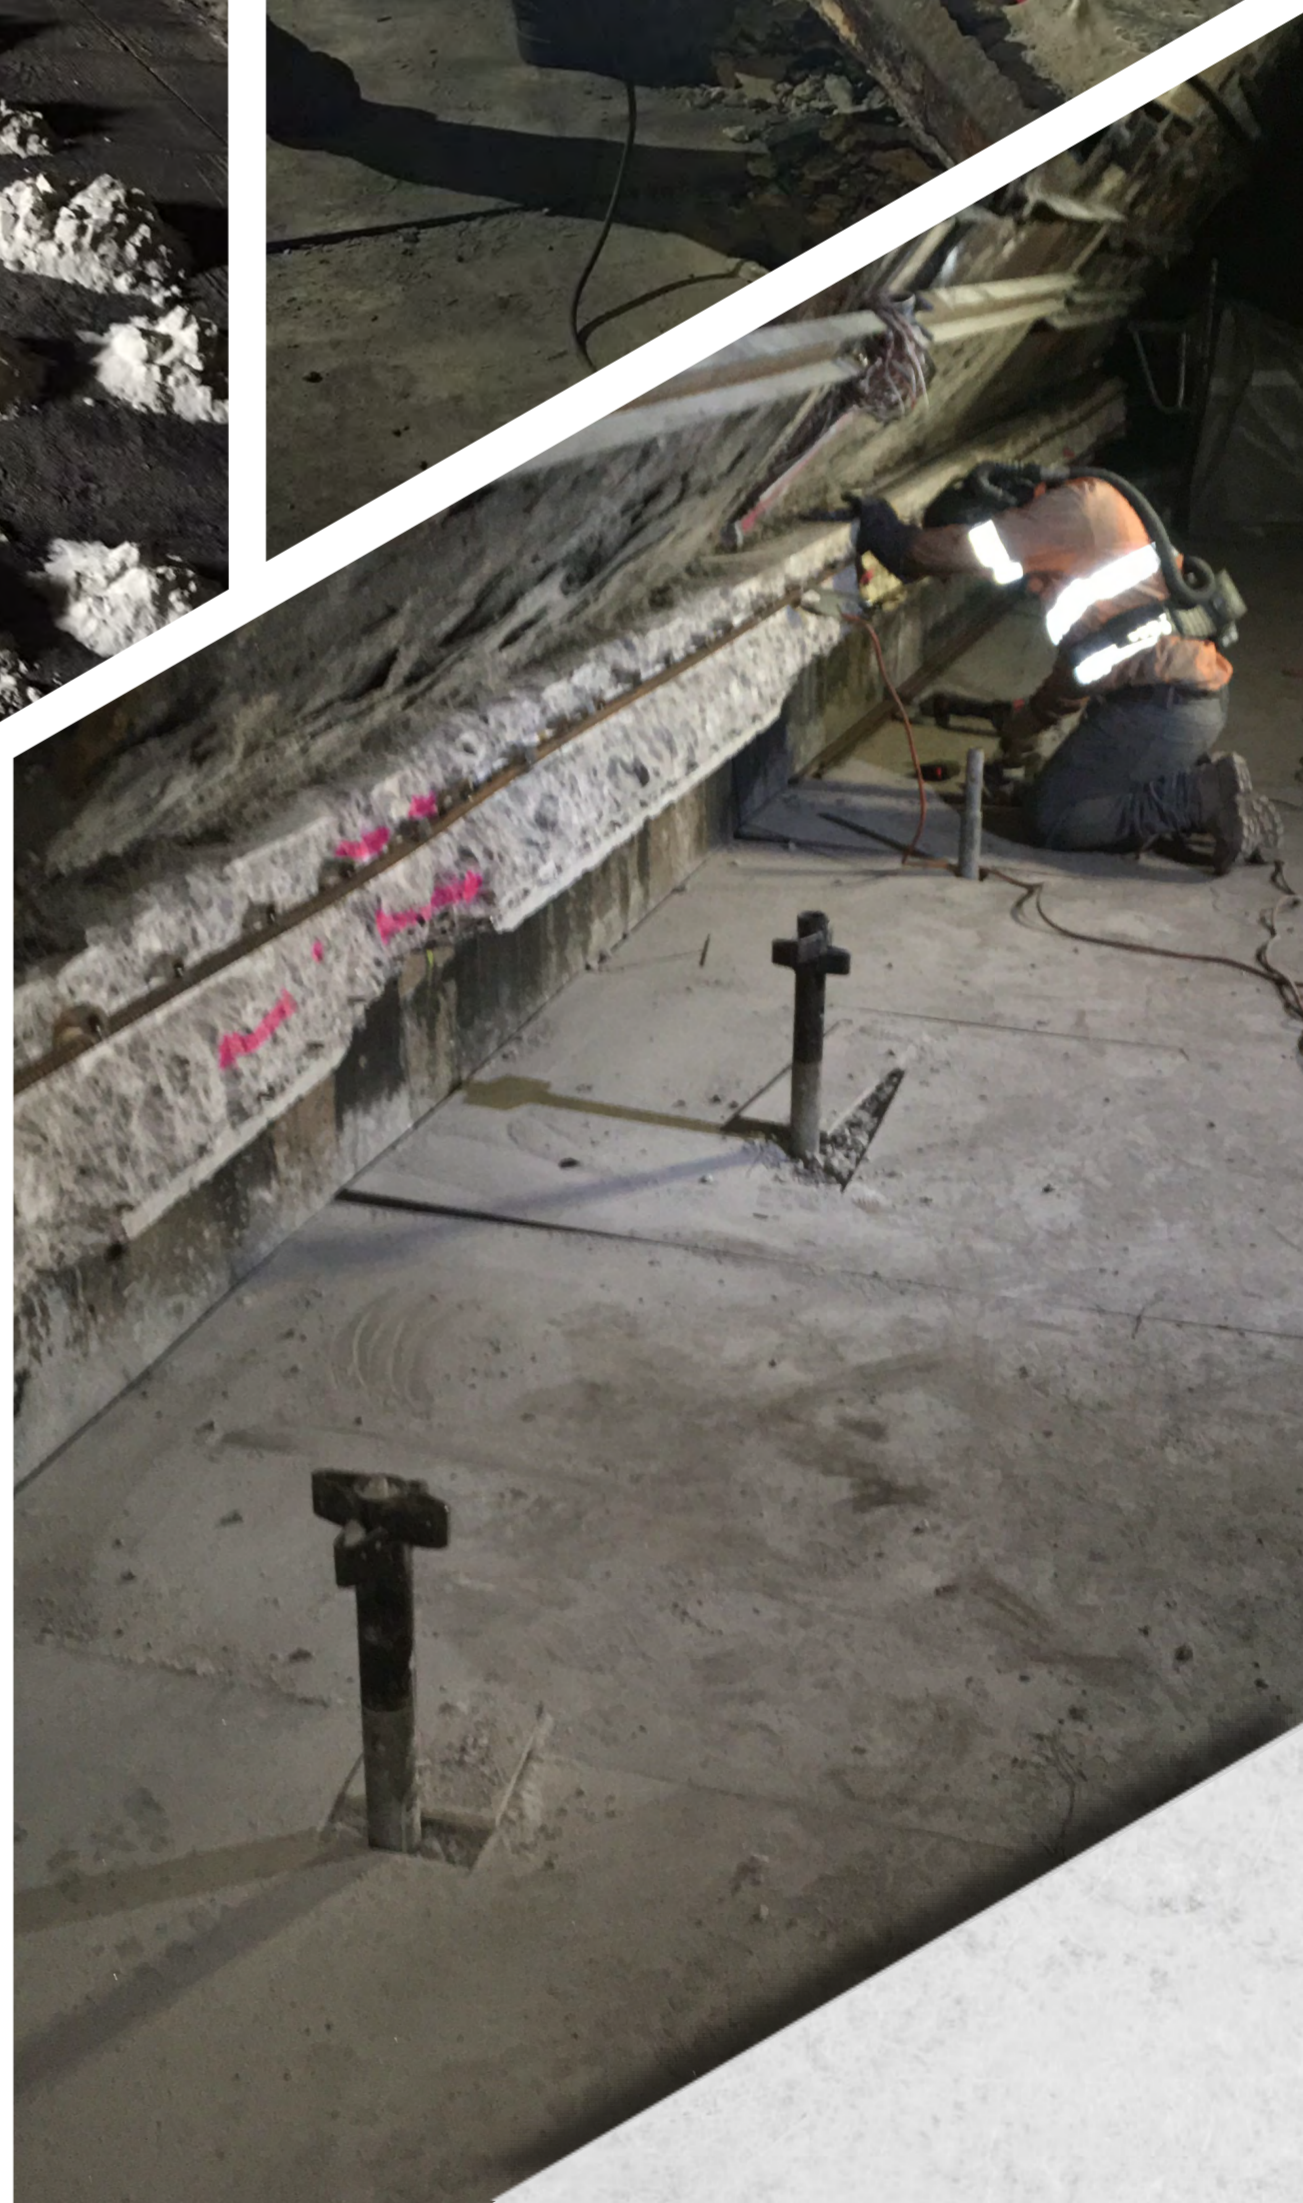
Remediation of the 8D Tunnel was essential to prevent further deterioration and leaking. Stage 1 of the project involved deconstruction and removal of the existing concrete shelf. QCCS adopted the use of Ecobust, a non-explosive demolition grout. Approximately 60 tonnes of concrete was removed. Limited access meant the rubble had to be transported up to 150m along the tunnel, by way of trolley systems. Stage 2 of the project required exposure of the existing reinforcement and welding of new longitudinal bars. Cathodic protection was installed to minimise the risk of future reinforcement corrosion. Works were completed with zero interruption to the Train Load Out.
